# **Navajo Abandoned Uranium Mine**

## **Site Screen Report**

### **John Lee Benally AUM Site**

**August 2010**

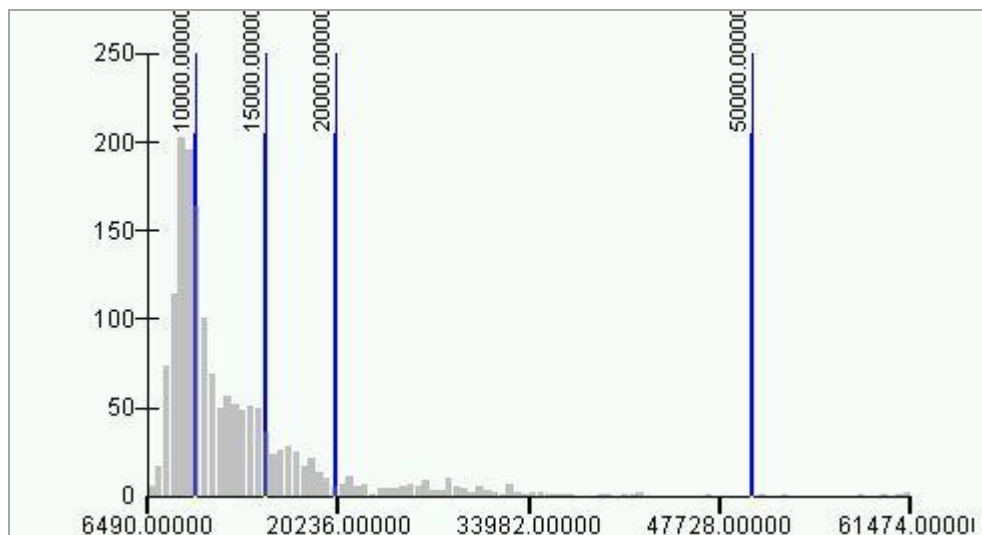
The following chart and statistics were generated by ESRI ArcGIS 9.3.1, and show the general distribution of the site gamma radiation measurements. The horizontal X axis represents the gamma radiation reading levels in cpm (lowest levels to the left). The vertical Y axis represents the frequency of each gamma radiation level.

Count:	1598
Minimum:	6490.00000
Maximum:	61474.00000
Sum:	20464502.00000
Mean:	12806.32165
Median:	10427.50000
Standard Deviation:	6260.32251

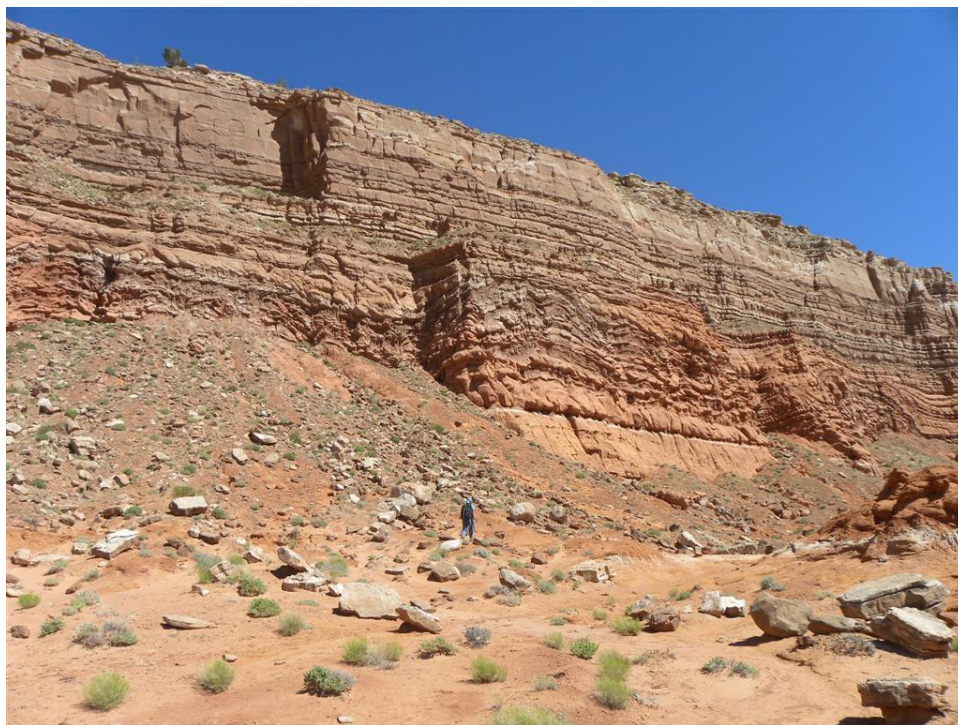
Photo 1. John Lee Benally site

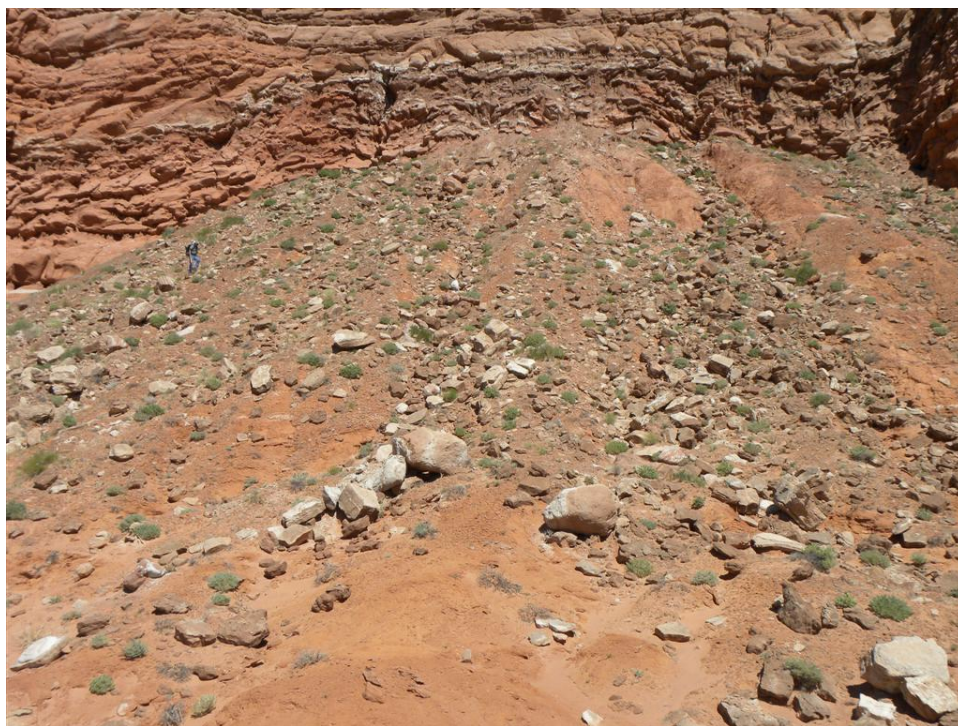
2 large slide areas (could be natural) 200' x 75' x 5' each

Photo 2. John Lee Benally site, possible waste rock

Possible unreclaimed waste rock

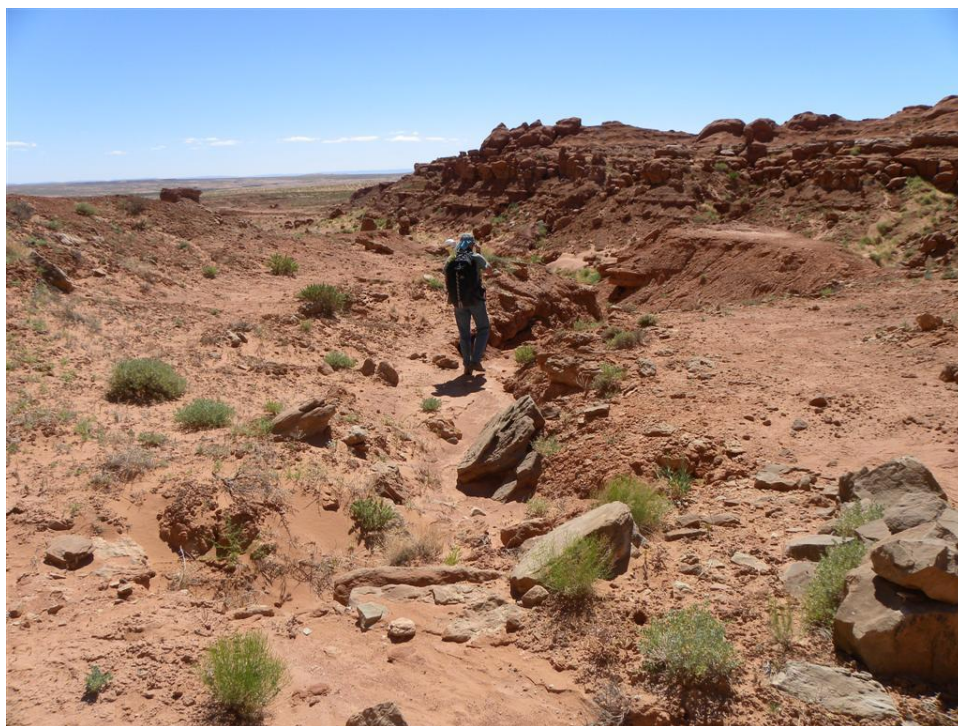
A total of 1,598 gamma radiation measurements were collected from the mine site, ranging from 6,490 cpm to 61,474 cpm. Measurements collected in the vicinity of the waste debris slide area were found at levels up to approximately 60,000 cpm, and in the drainage below the slide at levels up to approximately 15,000 cpm. The measurements are represented in Figures 1 and 2.

Photo 3. John Lee Benally site, drainage

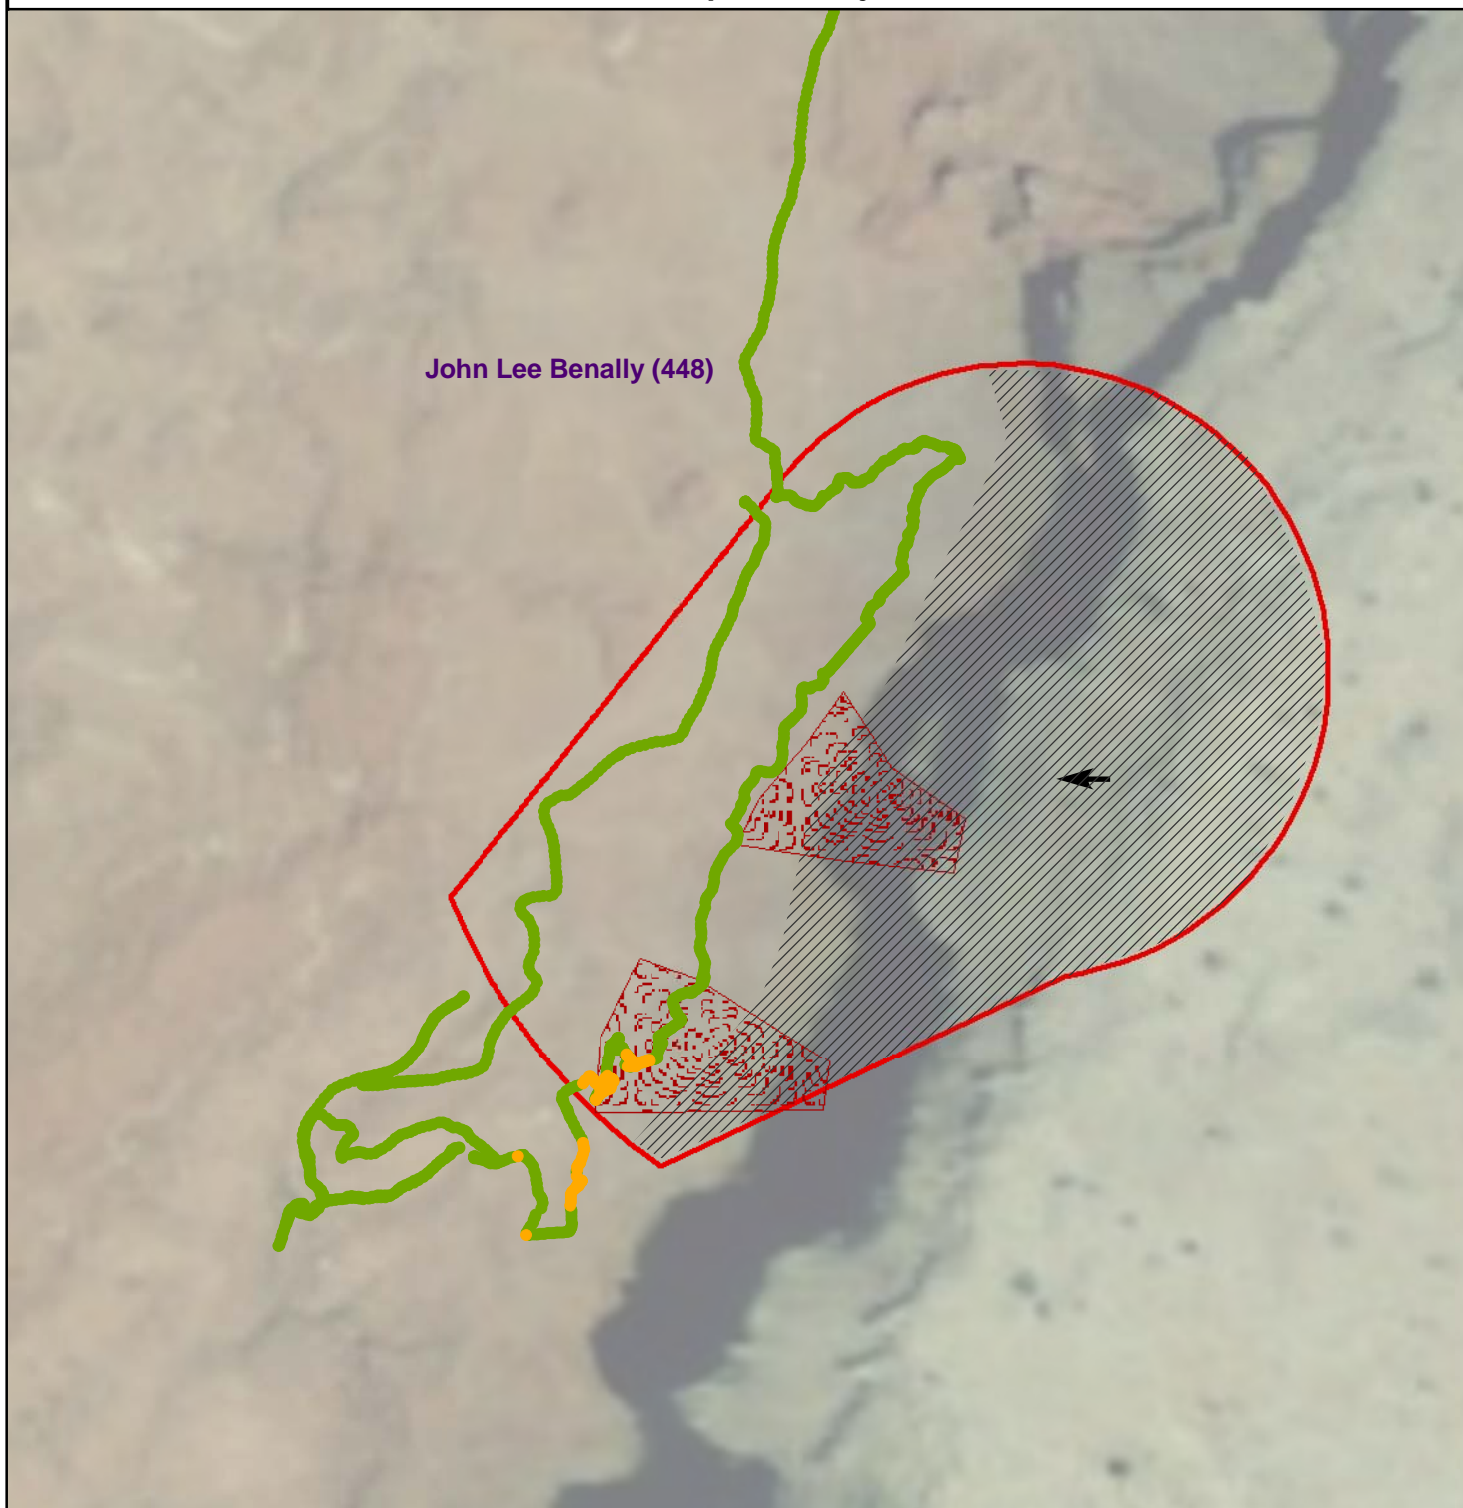
**Figure 1 - Gamma Radiation Measurements, Above Two Times Background**  
**John Lee Benally (448)**  
**Red Mesa Chapter, Navajo Nation**

Gamma survey conducted 06/2010  
 Measured as counts per minute (cpm)

Average background = 9,640 cpm

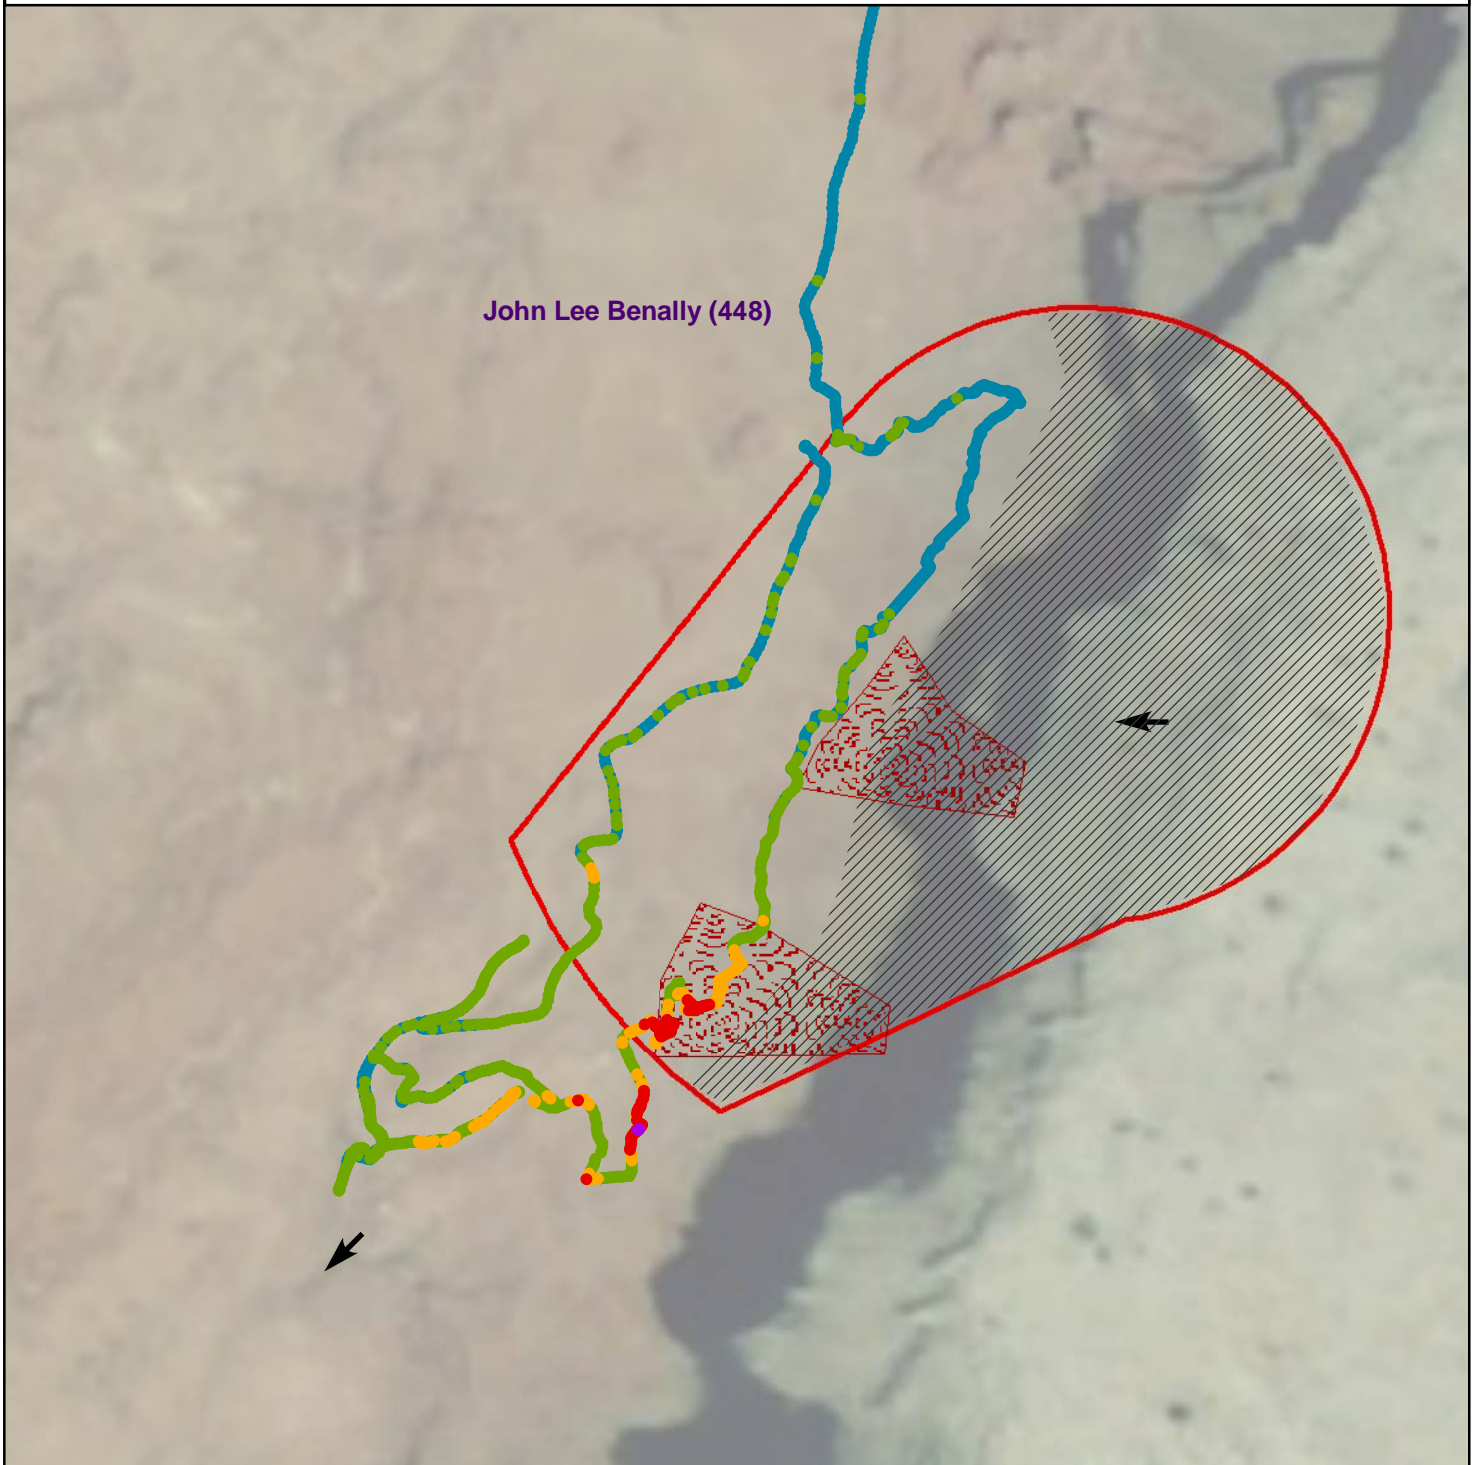
**Figure 2 - Gamma Radiation Measurements**  
**John Lee Benally (448)**  
**Red Mesa Chapter, Navajo Nation**

Gamma survey conducted 06/2010  
 Measured as counts per minute (cpm)

Average background 9,640 cpm
